# Trolley Lines

*Published by the North Jersey Electric Railway Historical Society*

ANNUAL 2018

## OPERATION BIG MOVE GETS UNDER WAY

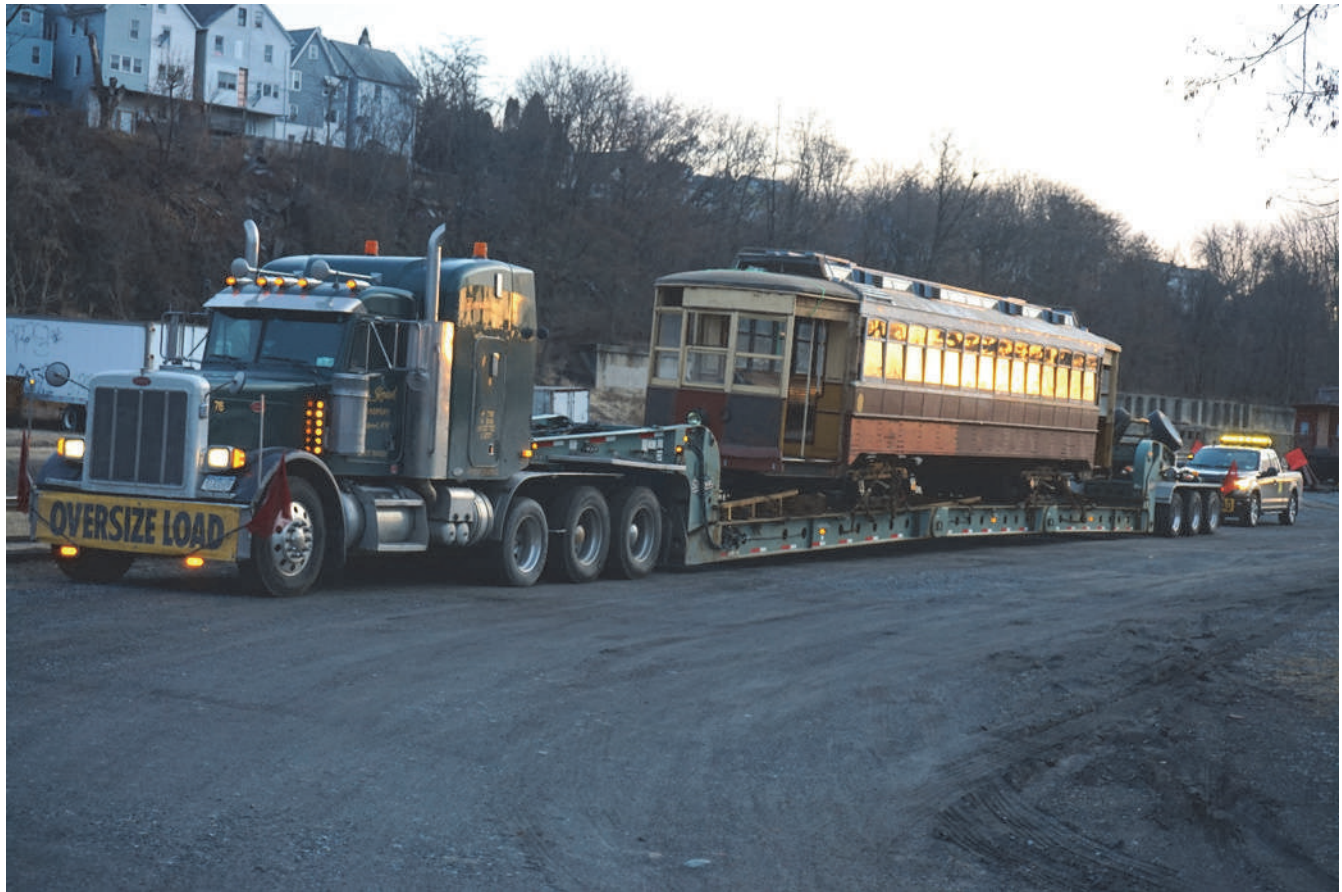
*Figure 1: A rosy fingered aurora had only just begun to bathe our windows in her palette of pinks when our Silk Road driver hurriedly and without assistance removed the trolley poles and bases to alleviate concerns regarding overhead clearances. January 25, 2018. Photo: Bob Hooper DSC04431*

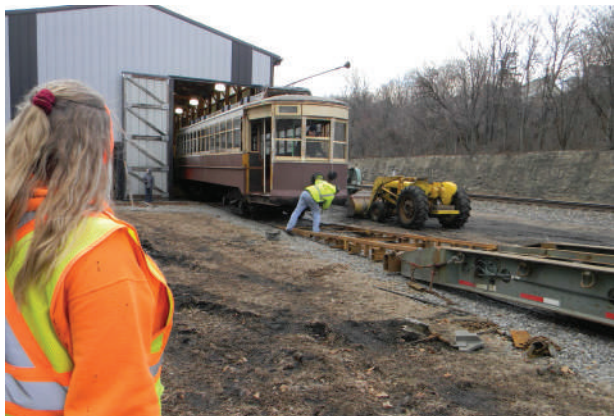
Figure 12: 2651 has just emerged from the car shed under her own power, as Lori Egresi observes. Silk Road driver Don Egresi secures the cable from the flat bed winch which will draw 2651 up the loading ramp onto the trailer. Photo: Tony Hall DSCN3197

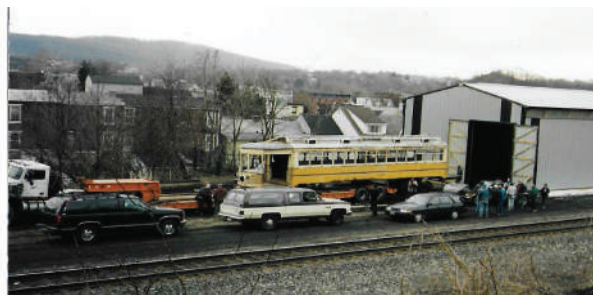
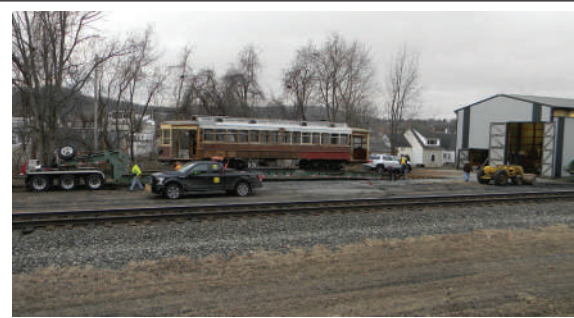
Compare these two views of 2651 truck-borne. Figure 16 At LEFT arriving from Ringoes in March 2001, after 27 years there of preservation and restoration. Photo: Tony Hall. Figure 17 At RIGHT after 17 more years of amazing progress at P'burg. We completed a new car roof, new custom safety glazing, authentic World War II seats, a rebuilt air compressor and brake cylinder and perhaps most importantly, a pair of C60 trucks with four working motors! Photo: Tony Hall DSCN3224

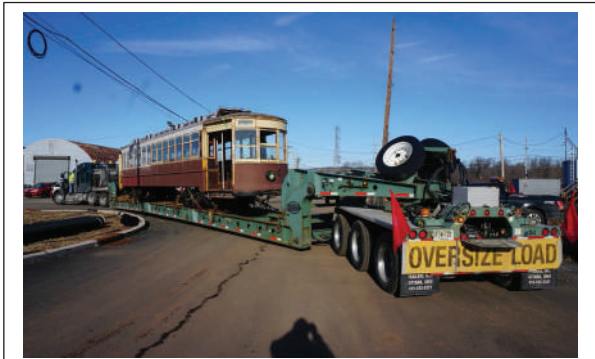
Figure 31: Having entered the property on an easterly heading, our rig has made a right turn passing before the ill-fated Quonsets. Now we are reversing onto an easterly heading preparing to cross the eight lead tracks to the main building. Note the steerable rear bogey, making the required moves possible. Photo: Bob Hooper DSC0449

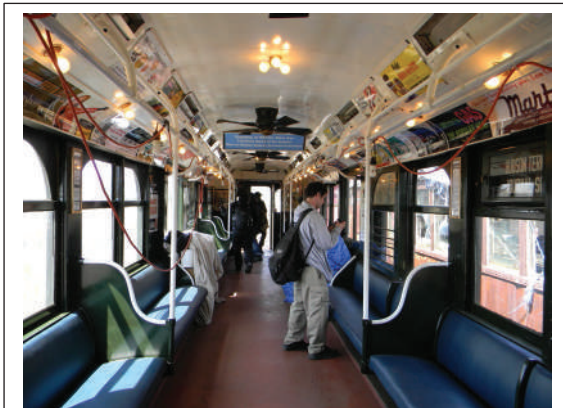
Figure 42: For a few years in the late 1960s, these fine old cars served the World Trade Center, until being displaced by the “K” cars. Note the “compromise roof” which had a limited but significant presence in New Jersey. Photo: DSCN3357

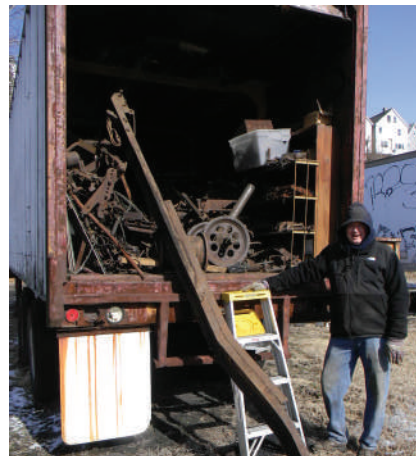
Figure 52: Bob Hooper has already retrieved the first of four steel knee beams from our warehouse for PSR 2683 Photo: DSCN3230

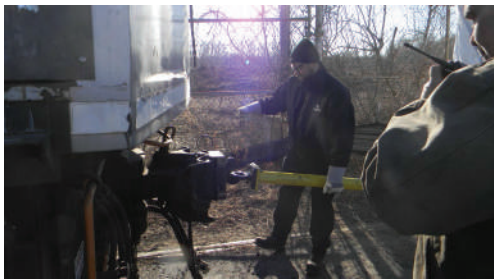
*Figure 68: Using a unique drawbar of their own design, KS crew couples #1 to ERDX 4139 (ex-NJ Transit) Photo: DSCN3124*

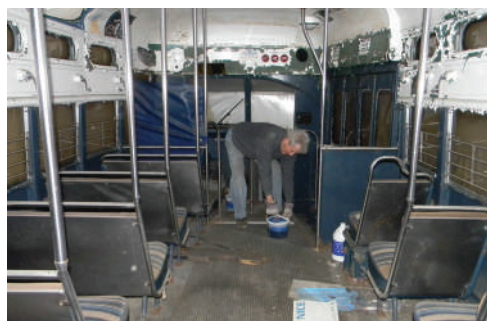
*Figure 71: Bob Hooper refreshes the desiccant in PCC # 1 to help reduce moisture inside the shrink-wrapped car. Photo: DSCN3258*

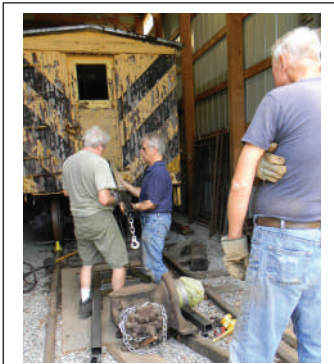
Figure 72: Bob, Hank and Jim secure the chains of Jim's portable lifting hoist to the compressor. Photo: DSCN3426

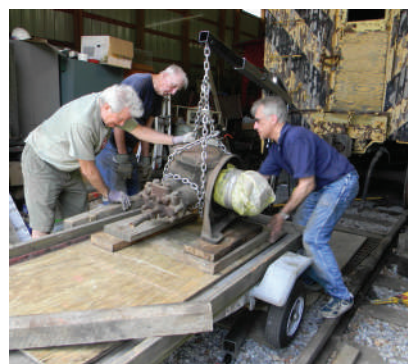
Figure 73: With considerable pushing and pulling, the spare compressor is raised and placed on Bob Hooper's trailer. Photo: DSCN3433

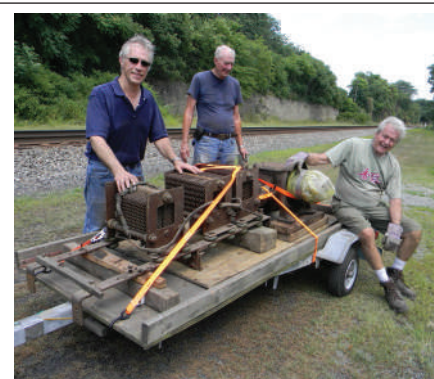
Figure 74: The spare compressor and resistor grids are loaded for transfer to Piscataway. Photo: DSCN3438

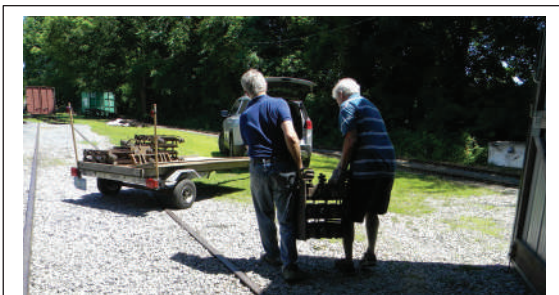
Figure 75: An advance crew moves several sections of resistor grids and other parts moved on June 16, 2018. Photo: DSCN3411

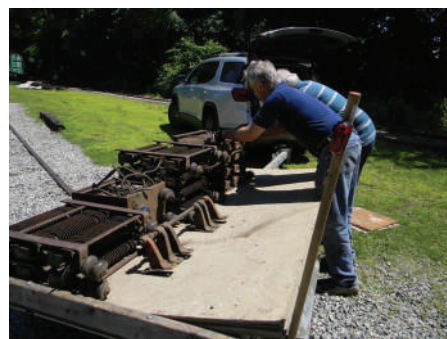
Figure 76: Parts for the folding steps are included in the continuing transfer of materiel. June 16, 2018 Photo: DSCN3412

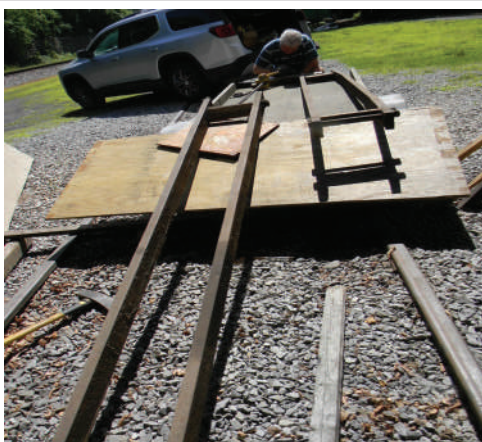
Figure 77: The lifting beam assemblies are winched onto Bob's trailer for moving to the Storage Trailer. Photo: DSCN3405

The Lifting Beams were originally part of our Boston snow plow trucks, and were assembled at P'burg for use in lifting the 2651 car body to facilitate the change of trucks.

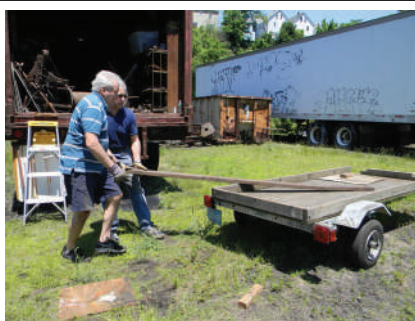
Figure 78: Manhandling the heavy beams, Bob and Jim transfer the steel objects to the storage trailer. Photo: DSCN3407

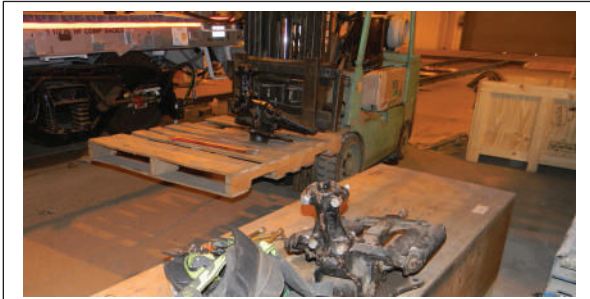
Figure 80: The trolley pole bases are prepared for lifting to the roof. One is in the foreground and one palletized beyond. Photo: DSCN 3272

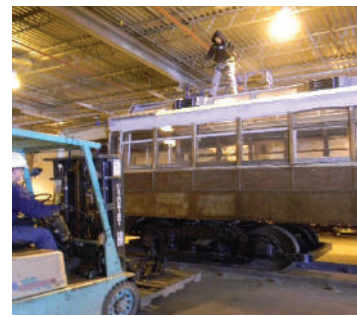
Figure 81: KS staffer Esteban is already on the roof, waiting for the palletized pole base to be raised. Photo: DSCN3277

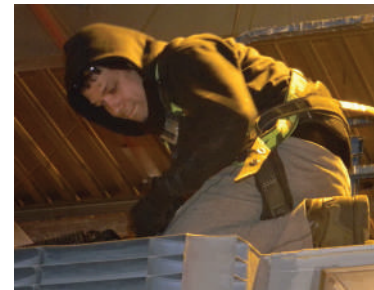
Figure 84: Esteban intently places the bolts to secure the first pole base. Photo: DSCN3300

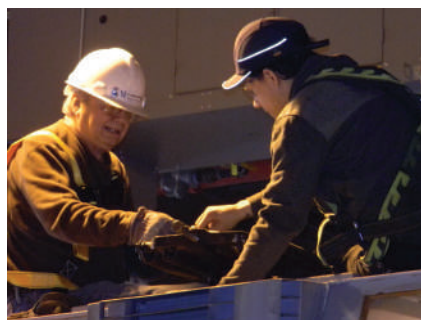
Figure 85: He is joined by Bob Hooper to complete the bolting down of the bases. Photo: DSCN3319

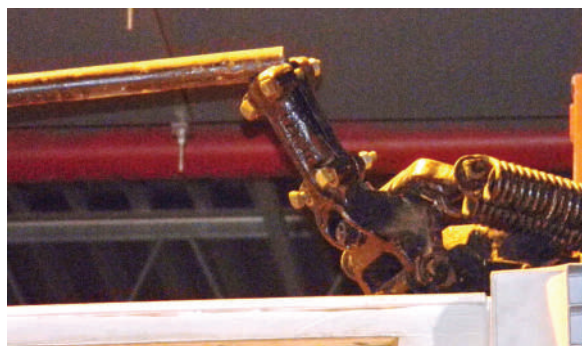
Figure 87: A problem arises, as yet unresolved; the pole receptacles, under heavy spring load, will not permit the poles to be inserted without interfering with the building ceiling. Photo: DSCN3324

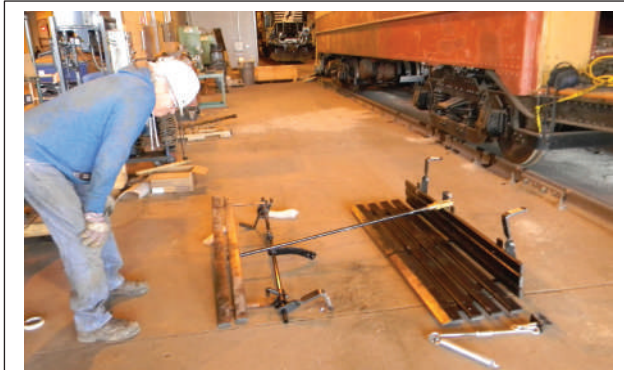
Figure 88: The Life Guard Fender Kit is set out to determine that all the parts are present and fit properly together. Photo: DSCN3326

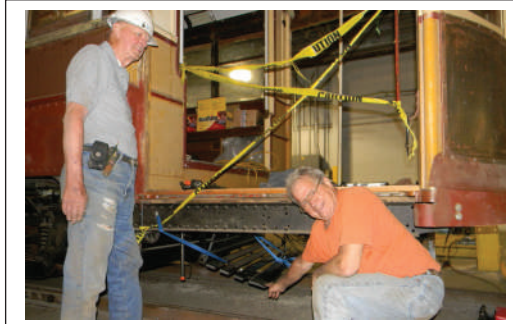
Figure 89: Hank Kaminski and Bob Hooper have wrestled the basket assembly into its approximate position. Photo: DSCN3384

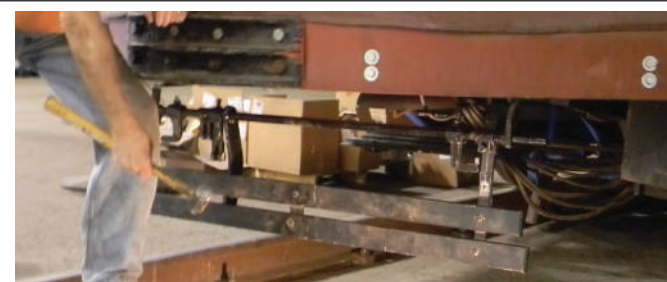
Figure 90: The forward trip gate is hung beneath the extreme front of the platform. Any inward motion of the gate will cause the basket (Fig 92) to drop to the rails Photo: DSCN3392

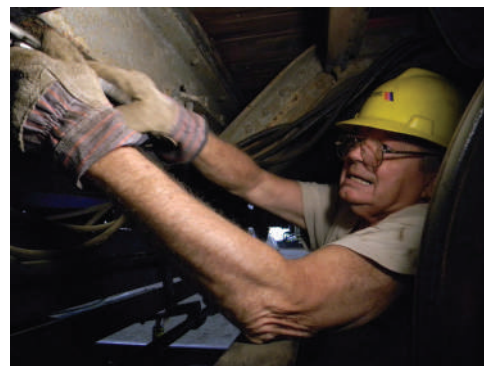
Figure 91: Not John Henry driving steel into a rock tunnel face, just Bob Hooper struggling to get the basket clamped into position under the platform. Photo: DCSN3398

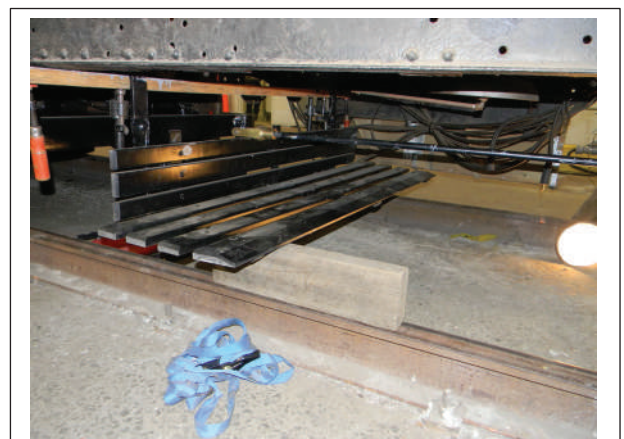
Figure 92: The Basket is successfully clamped into position ready for permanent assembly. Photo: DSCN3400

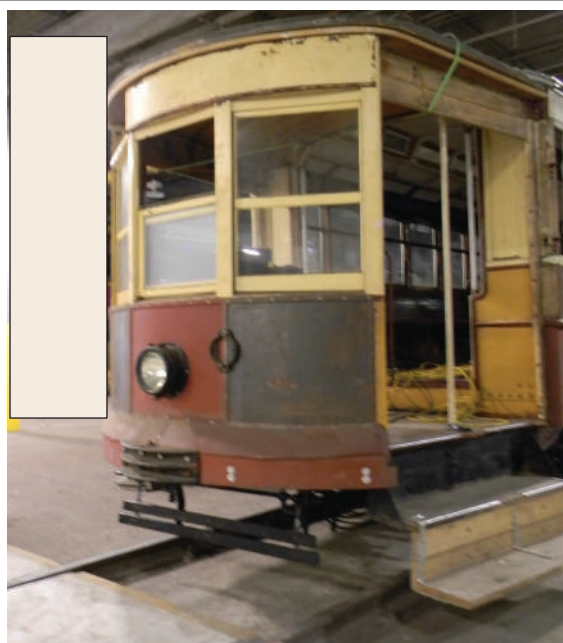
Figure 93: While seeming simple, the front trip gate hides a life saving device beneath the platform. Photo: DSCN3394

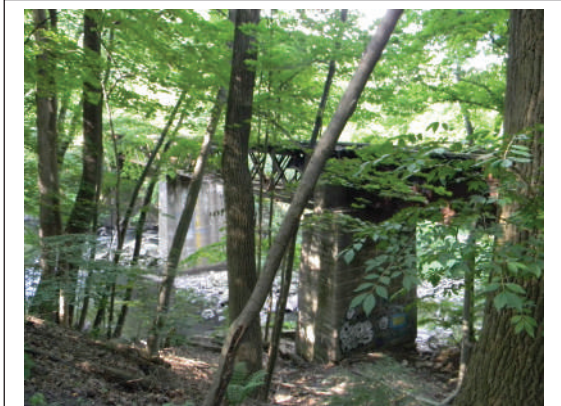
Figure 96: An outstanding feature of this site is the steel bridge spanning the Rockaway River Gorge. Photo: DSCN3422

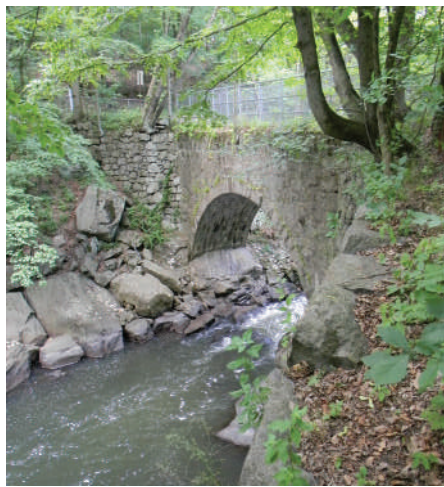
Figure 99: The foot bridge over the river was constructed of hand cut stone quarried on site. Photo: DSCN3415

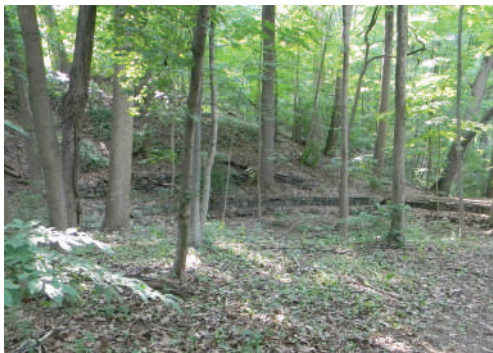
Figure 100: The Turntable Pit is rapidly becoming a forest. Photo: DSCN3421

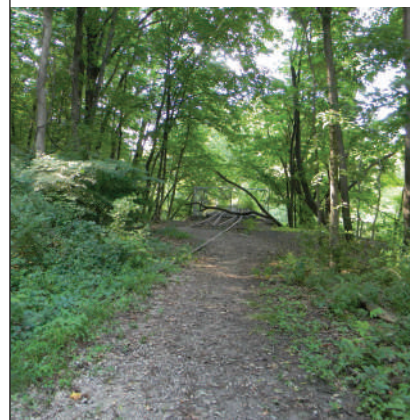
Figure 102: This right of way is almost entirely intact, from the River bridge up the gorge to the quarry and the Falls, including much of the abandoned track. Photo: DSCN3420
