# Trolley Lines

## **NJERHS GARNERS GRANT FOR THE PAINTING OF 2651. LIBERTY HISTORIC RAILWAY TO FUND THE PROJECT. KINKISHARYO TO PERFORM THE WORK.**

## Prepping Begins

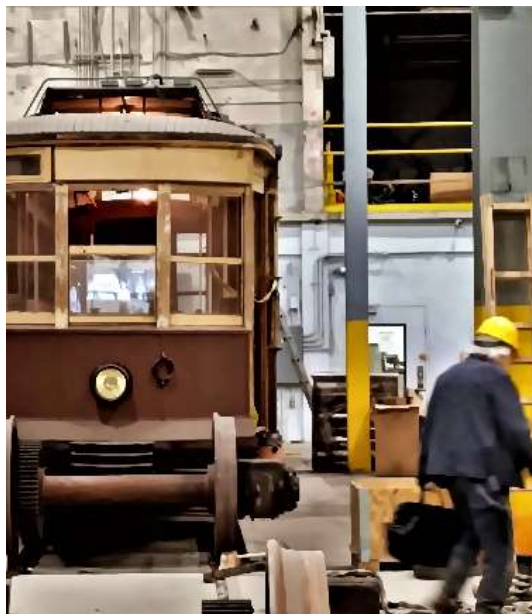
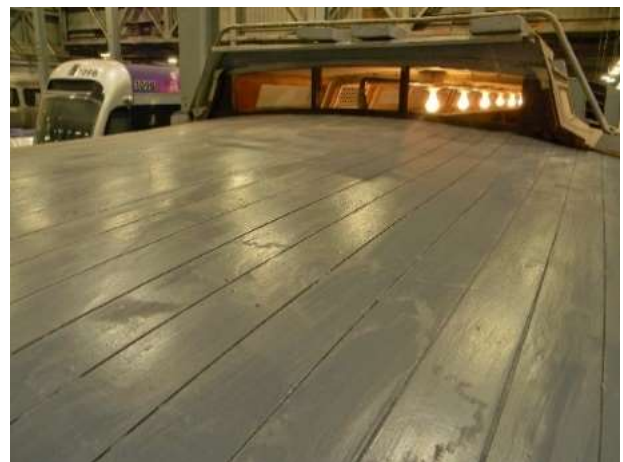
One of the first tasks at hand was to enamel the sheathing of the bonnet roofs in order to protect the ancient planks from any errant moisture that might infiltrate the canvas cover to come.

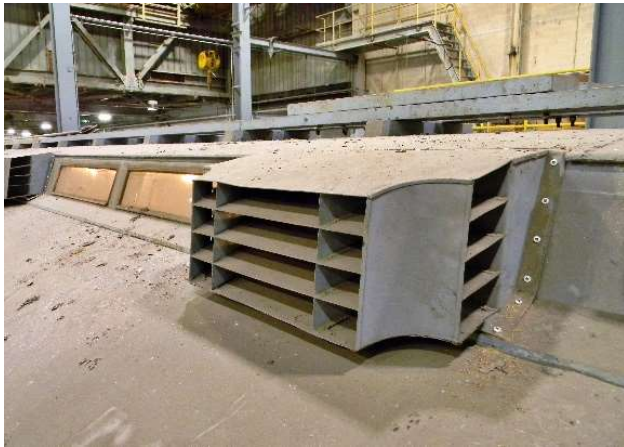
Hurried temporary mounting of all eight ventilators back in 2017 now required a more permanent solution.

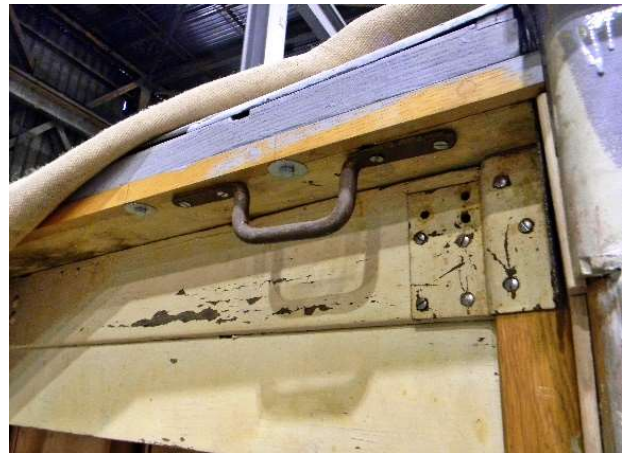
The original underbonnet grab handles proved to be too small even for Tony's diminutive grip ...

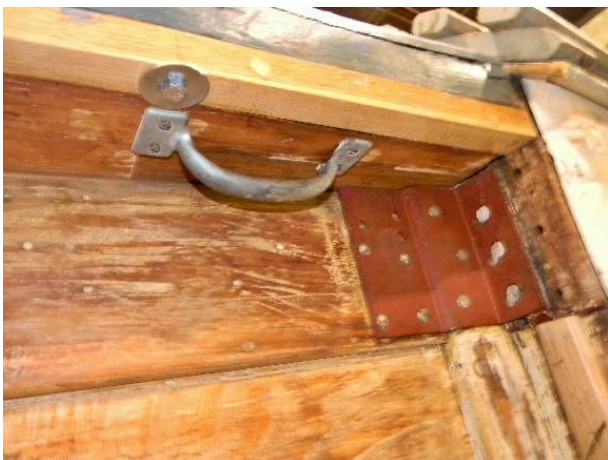
,... so modern, larger ones were substituted.

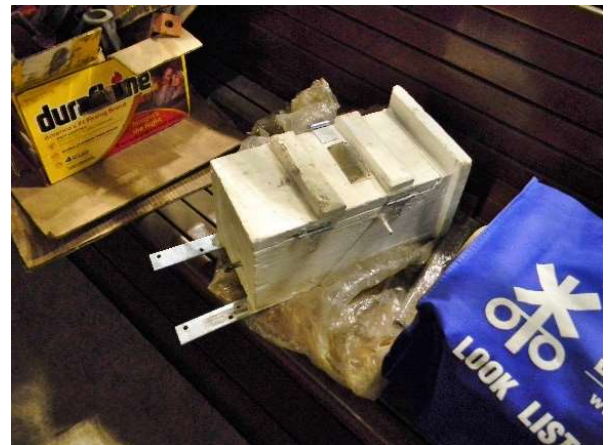
The lightning arrester, cosmetically restored by Tony, awaits installation.

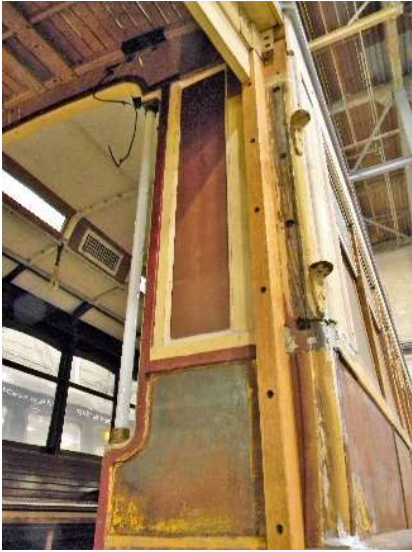
Bulkhead panels, removed in the P-Burg years by Hank Kaminski to facilitate structural repairs beneath, had to be refitted along with appertinent mitered quarter-round moldings.

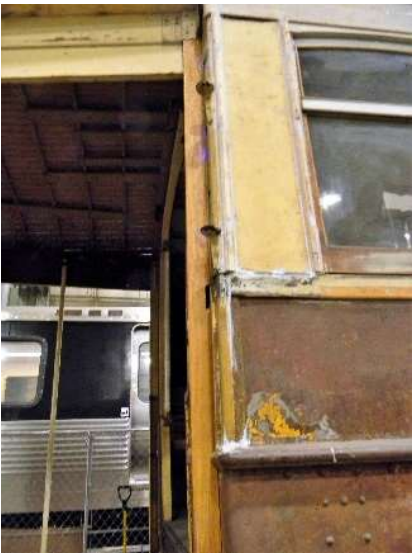
Teamwork gets 'er done! NOTE: The only place on the car where sheet metal sheathing rust out was repaired with a fiberglass / epoxy patch. (Circa 1976 at Ringoes).

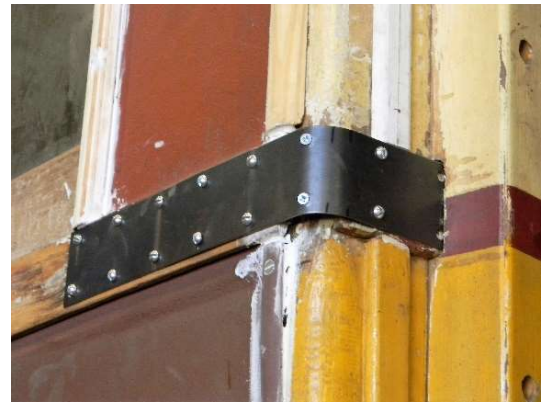
No, NOT the battleship NEW JERSEY, just one of four corner plates re-manufactured by our friends at Kinkisharyo LLC from a rusted out original and installed by Tony.

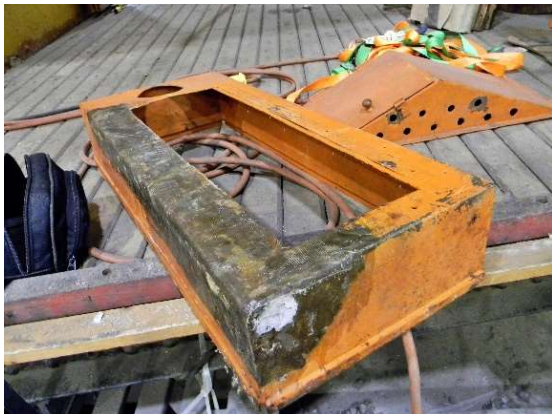
The destination sign box from the "B" end had suffered what many diagnosed as terminal rust-away. But, Doctor Bob Hooper to the rescue! Bob removed the dead "tissue" and skillfully regenerated new "flesh" using fiberglass and epoxy resin. Where do we find such people? We could use a few more, if you're out there!

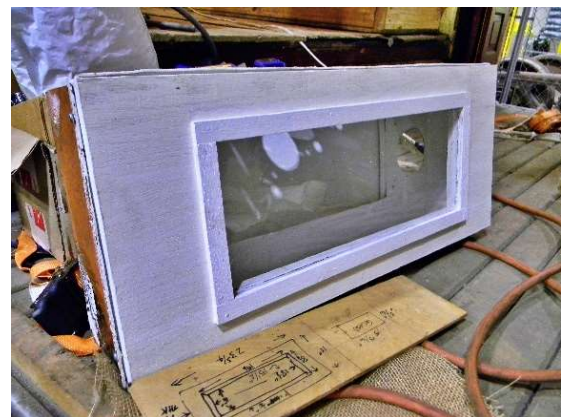
A new sign box cover was made up by Jim Houston, replicating the one at the "A" end, built by Tony at P-Burg years ago.

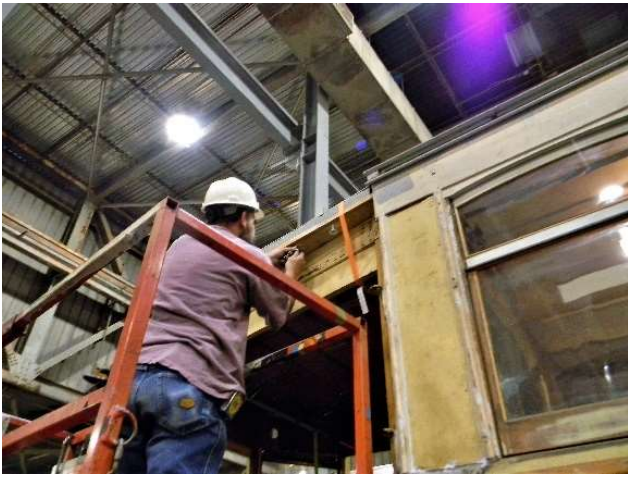
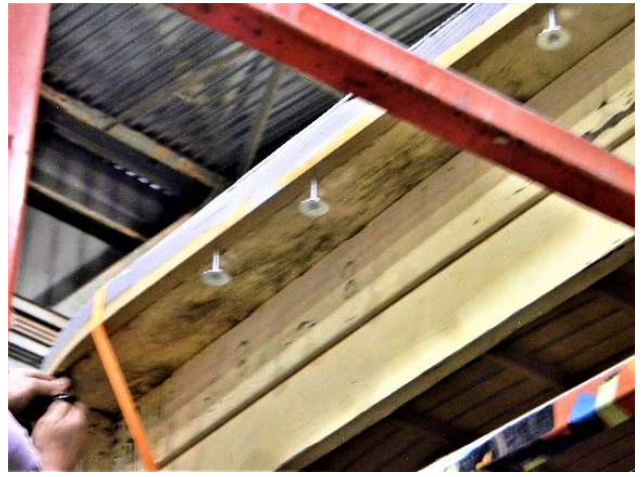
Hurried preparation for the move to Piscataway required that the bonnet roofs be attached to the car using only temporary clamps and ratchet straps. Now we needed yet another more permanent solution. Here Marc has pre-drilled the bonnet plates and is inserting lag screws to finally secure the end roofs to the car.

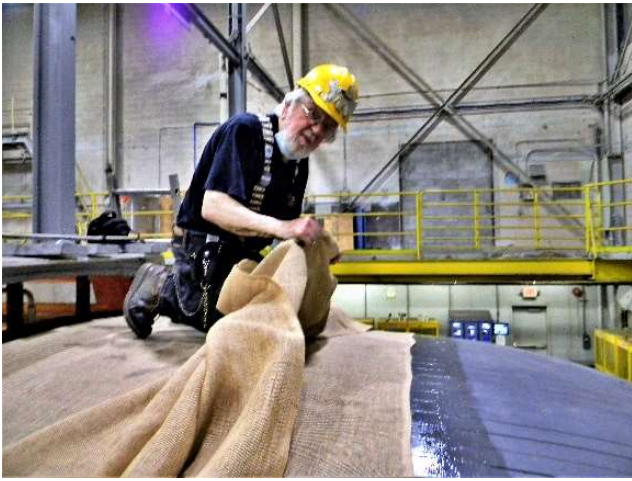
Jumping ahead to the "A" end, Quasimodo, temporarily neglecting his bell-ringing duties, and having applied a strip of contact cement to the bonnet deck, here deploys the burlap underlayment. (Photo by Jim Houston)

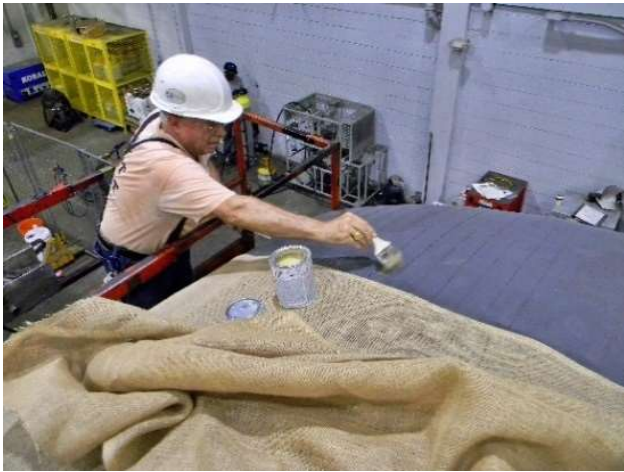
Similarly, back at the "B" end, Jim lays down a strip of cement to secure the burlap in place during the overlaying of the canvas to come. Thus, will a wrinkle-free outcome be assured.

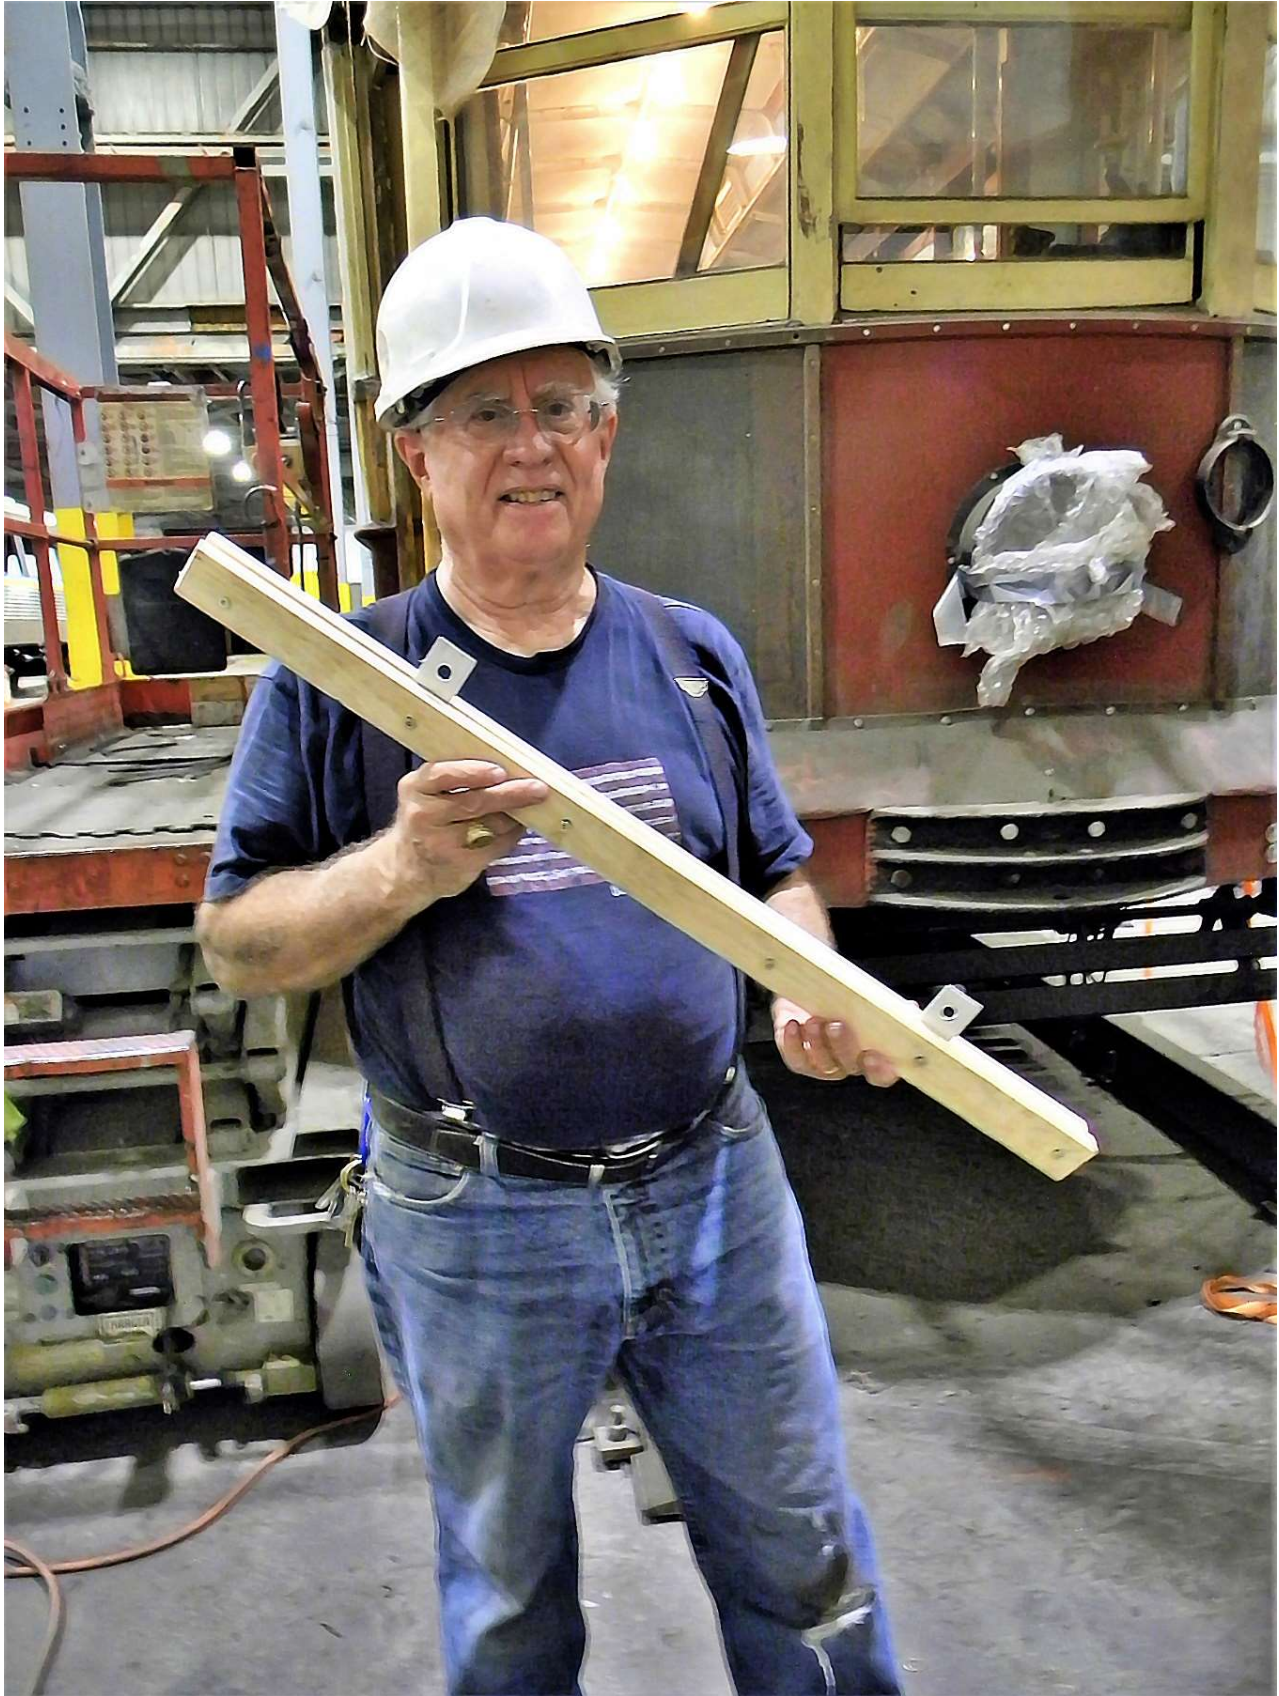
Jim Houston proudly displays his own designed and built "Canvas Grippers," patent pending.

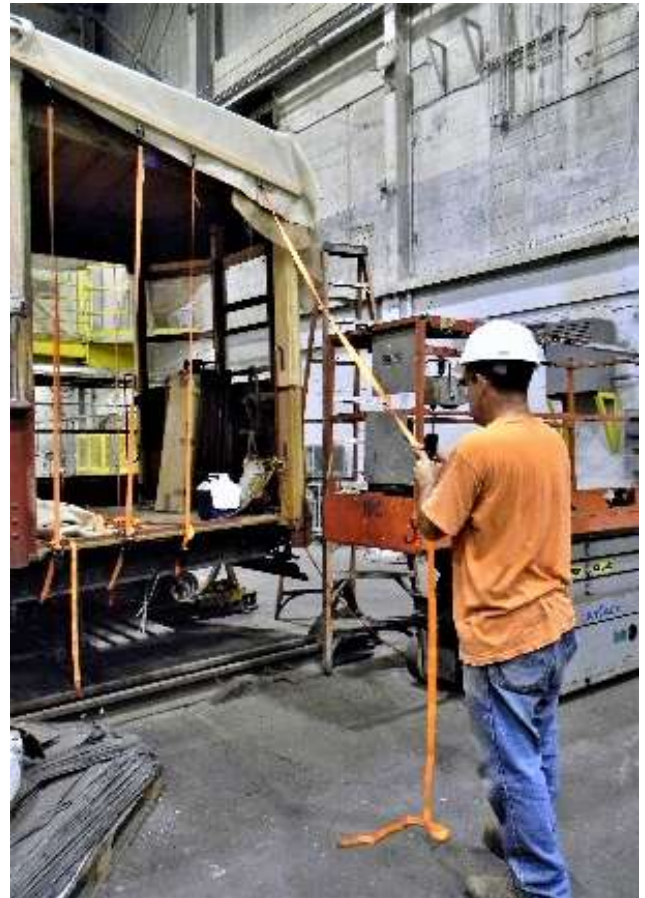
Marc tests one of the ratchet straps, drawing tension on the canvas to remove wrinkles from the roof covering.)

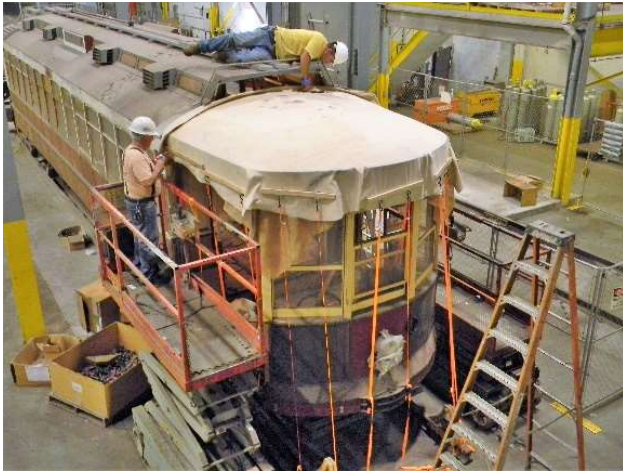
After the canvas had had a week to stretch and settle, the Corps of Restoration begins measuring and predrilling for the many short roofing nails which will permanently hold the canvas in place.

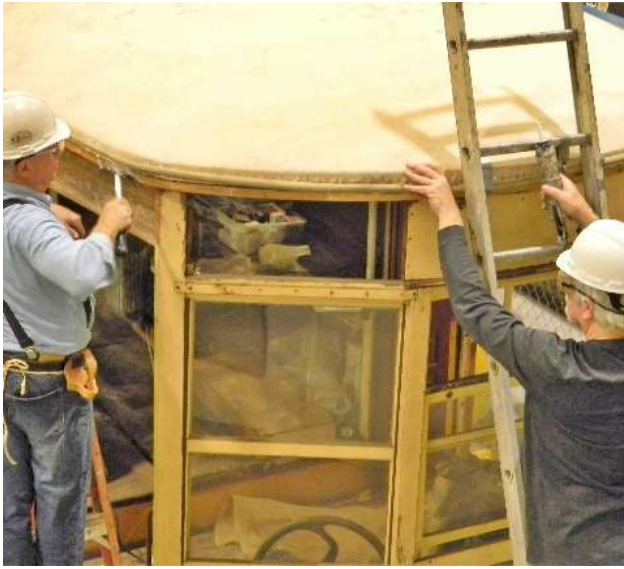
Plastic molding goes neatly into place with thanks to Hank Kaminski who recommended OutWater Plastics of Bogota, NJ as our source.

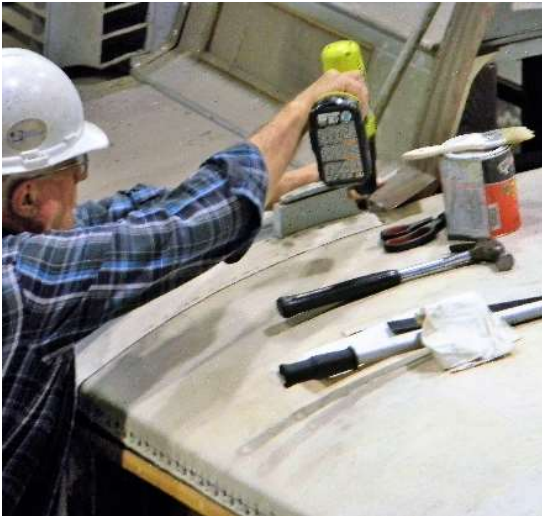
NOT SO FAST! On this job, there are ALWAYS one or two more tasks that need to be done. Here, Jim pre-drills for the necessary canvas strips which will cover the gaps between the bonnet roof and the main car body.
